# NEW TRANSFORMER MONITORING TECHNOLOGY GIVES SPEEDY RESULTS

# PRODUCT PICK: NON-DESTRUCTIVE TESTING (NDT)

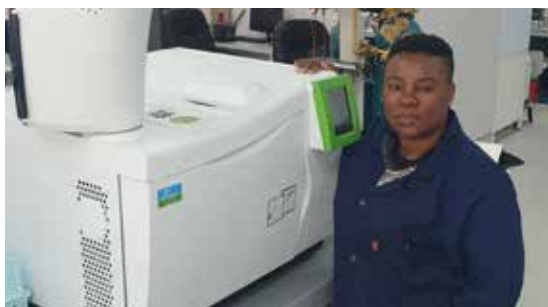
*WearCheck transformer laboratory technician, Zamaswazi Dlamini, operates the new high-speed gas chromatograph (GC) in Durban. The GC, one of two new ones, has more than doubled WearCheck's capacity for processing dissolved gas analysis DGA on transformer oil samples*

The new Perkin Elmer GCs – designed and manufactured in The Netherlands – each have a carousel that can hold 120 prepared samples and standards. Added to the 80-sample capacity of the existing GCs in the Durban laboratory, with more samples being processed at any one time, the sample turnaround time has been significantly reduced. The same instrument was bought for the Johannesburg lab, boosting their existing GCs.

'The primary function of the GC is to perform dissolved gas analysis (DGA) – a highly effective preventive maintenance tool which has formed part of WearCheck's condition monitoring programmes for more than 10 years,' says Nel.

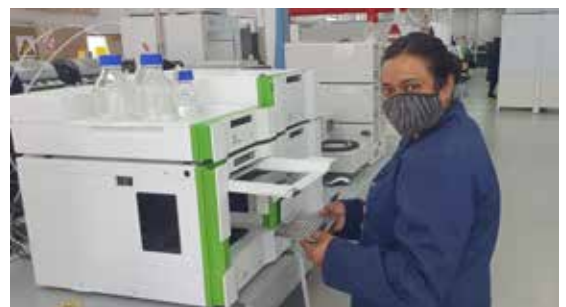
*Senior analytical chemist, Lynette Pillay, feeds samples into the new HPLC (high performance liquid chromatography) machine at WearCheck's transformer laboratory in Durban*

'The additional HPLC,' continues Nel, 'separates mixtures of compounds in transformer oil to identify and quantify the individual furanic compound concentrations of the oil. The results enable our diagnosticians to predict the remaining useful life of the paper insulation of the transformer with high accuracy, giving a very good indication of the remaining useful life of the transformer itself.'

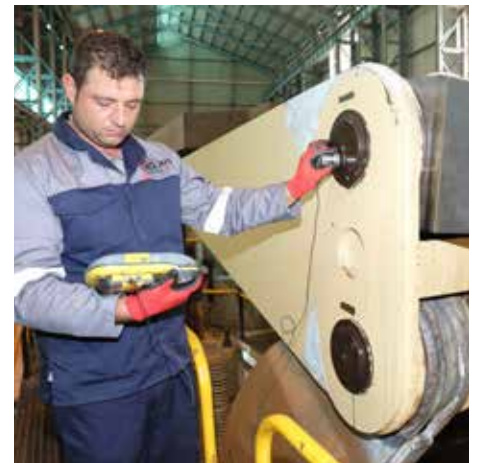
WearCheck's senior machinery inspector, Jaco Venter, conducts ultrasonic testing on a winder's brake components during a non-destructive testing (NDT) routine

During the process, an ultrasonic flaw detector instrument fires ultrasonic pulses into the material, and simultaneously detects the reflection. By measuring the time difference between the pulse and the reflection and knowing the speed of sound in the test material, you can pinpoint the location of the defect.
